## North Coast Regional Water Quality Control Board

### Water Quality Inspection Report

**Inspection Date: January 28, 2019**

Main production area and fields at 647 Nissen Road, Ferndale, CA, Eel River Watershed.  
Additional cattle raising area at 3210 Goble Lane, Ferndale, CA, Salt River Watershed.

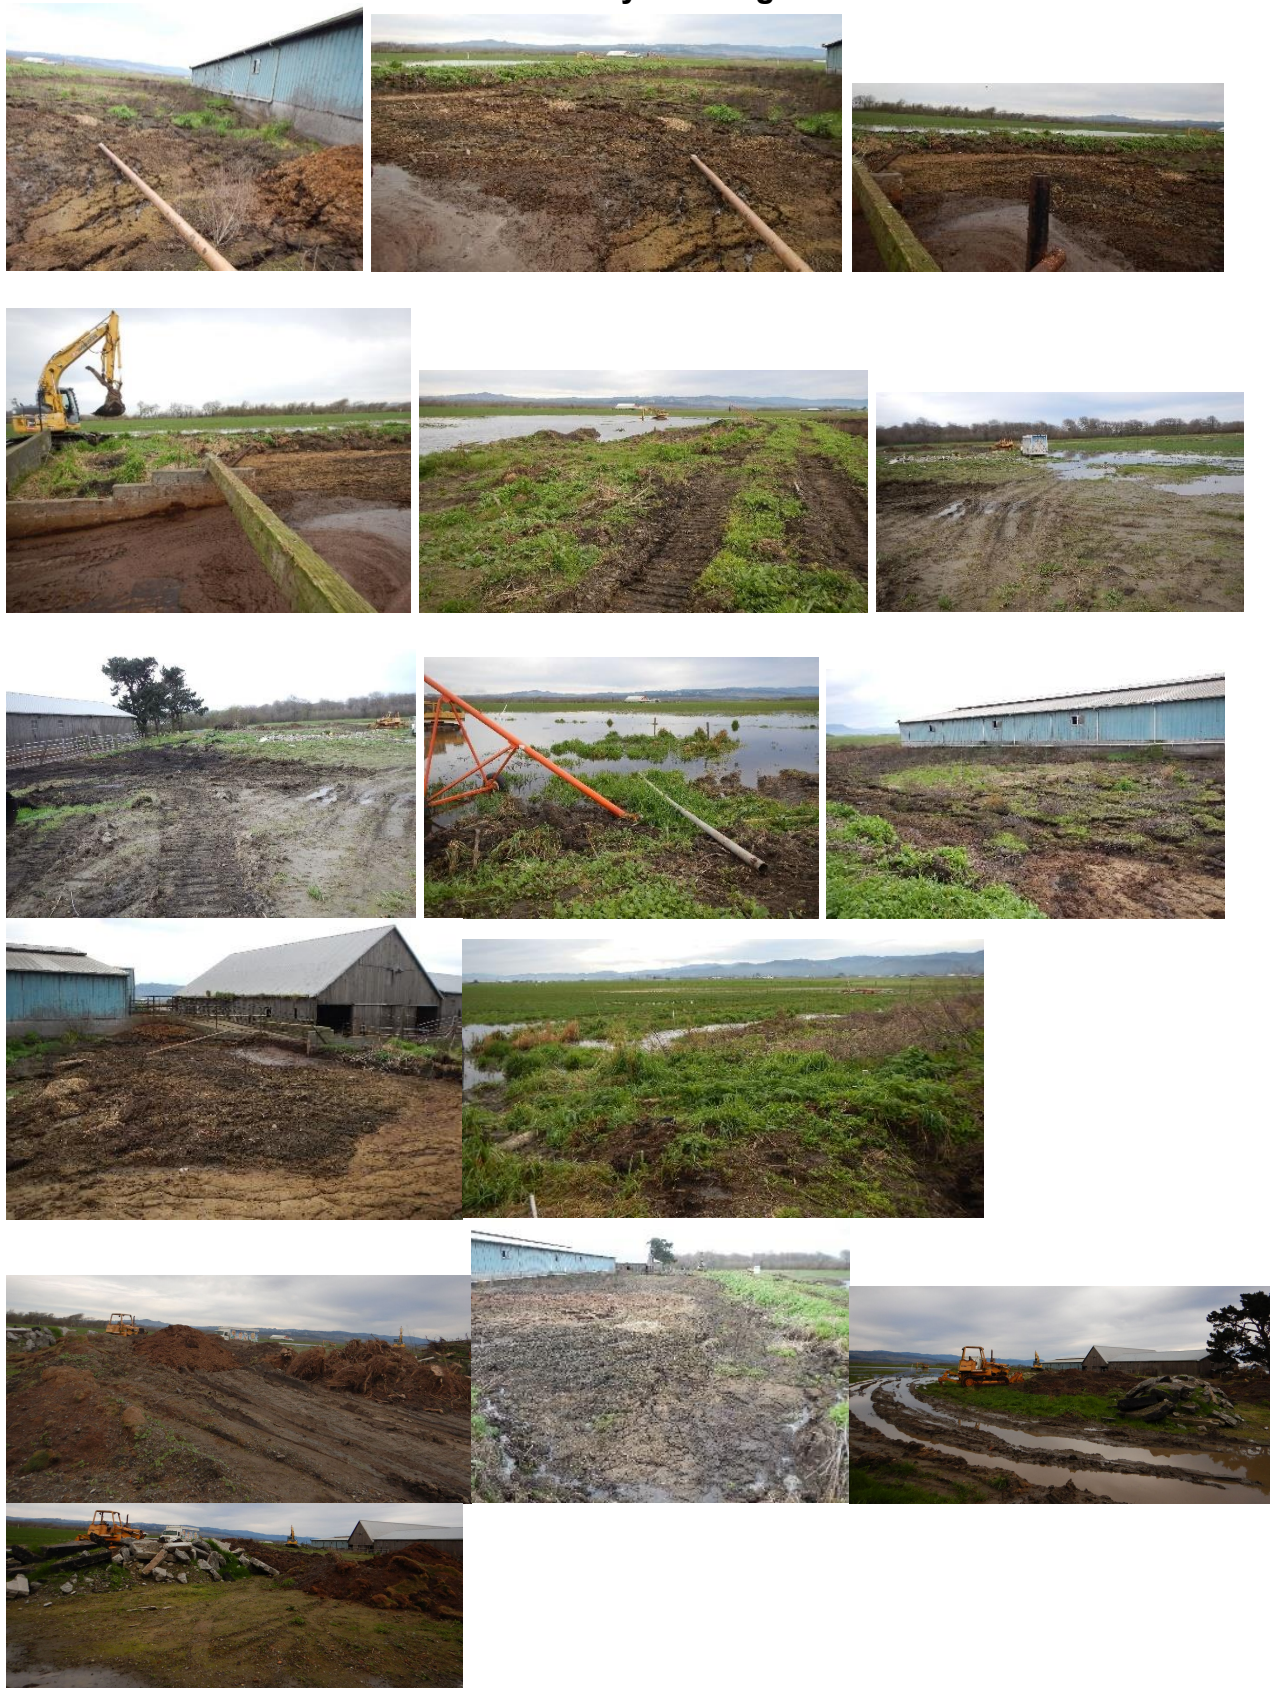
**Area A: Manure Pond Area north of Dairy Buildings**

Ms. Blatt, Ms. Heintz, Mr. Mario Avelar, and Mr. Victor Avelar walked through a barn to access the manure pond area. Mr. Victor Avelar opened the gate so that Ms. Blatt and Ms. Heintz could take close-up photos of the manure pond. The manure pond appeared to have several feet elevation of capacity. Rain gutters at dairies should collect clean roof water and discharge away from manure ponds to retain capacity in the manure pond and prevent overflow, however, the rain gutters on the buildings contained large tufts of grass in some areas, had disconnected or missing pieces in other places, and generally were observed to be non-operational. **Recommendation 1:** The roof rain gutters had plants growing in them and had sections in disrepair. The roof rain gutters must be cleaned and repaired to discharge clean rainwater away from the manure pond.

Disturbed soil and tire tracks were observed and photographed along the north side of the farm buildings from Nissen Road to the west end of manure pond berm. Water was pooled in a low spot in the field to the north of the manure pond. Several ducks were swimming on the surface of the pooled water in the field. Irrigation equipment was located on the edge of the pooled water near the east end of the manure pond. Mario stated that the water was from recent rains. An approximately one-half acre area of over 90 percent bare disturbed soil was observed north of the dairy buildings from Nissen Road to the manure pond.

**Recommendation 2:** To keep soil in place and uptake nutrients, this area must be vegetated prior to the rainy season.

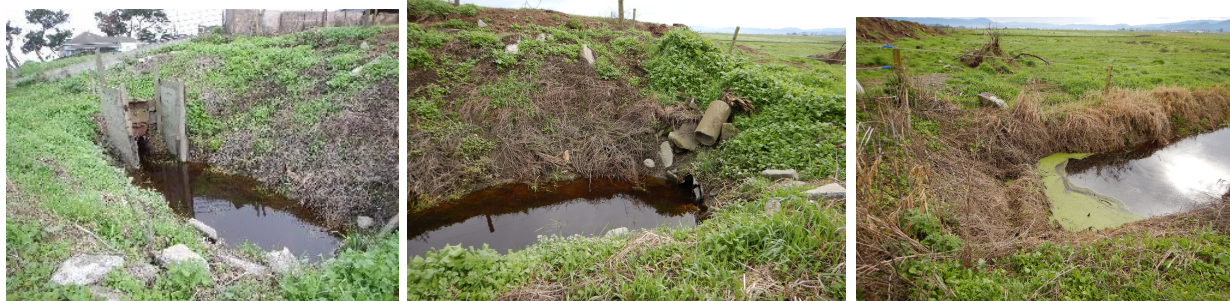
**Area B: Wood shavings cow loafing lot along Nissen Road**

Next, we walked along Nissen Road to the wood shavings lot that is built up with fill soil, rock, and wood shavings to form a cow loafing lot at a higher elevation than the surrounding pasture. Vegetation was observed between the loafing lot and the ditch of

Nissen Road. Under a driveway of Avelar Dairy is a 32-inch diameter culvert that has a gate that opens and closes the culvert inlet. Mr. Mario Avelar said that he closes the gate on the culvert when Eel River flows are high to prevent backflow flooding his dairy. When the Eel River is at a low elevation such as on the day of the inspection, the gate is open and water from the slough flows freely from neighboring properties, the Avelar pastures, and the Nissen county road ditch to the Eel River. Regional Water Board staff observed the gate on the culvert in the open position during the inspection and did not observe any discharges from the loafing lot to the ditch. A second culvert is located under another driveway to the pasture just south of the entrance driveway. No surface water was evident between the Avelar driveway and the Eel River. Mr. Mario Avelar and Mr. Victor Avelar said that is because the water flows in the 32-inch diameter culvert, 1,350 feet long, to the Eel River. The Avelars said that the culvert was installed over 20 years ago before they purchased their property. The outlet of a metal culvert that connects to the mentioned culvert was broken and the inlet of this culvert was blocked with heavy vegetation and a small algal bloom was observed. (photos attached). The Mario and Victor said that the slough to the west of Nissen Road in this general location is clogged and does not drain to the Eel River.

Mario said the wood shavings lot contains wood chips to soak up rain runoff and the lot is sloped to drain toward the pasture. No cows were observed on the wood shavings lot and there was no evidence of rilling on the west edge of the wood shavings loafing lot, however it is possible that stormwater that contacts the wood shavings lot could discharge waste to the culvert inlet area that ultimately flows through the long culvert the 1,350 feet to the Eel River. The discharge of waste to the Eel River and its tributaries is prohibited by the Conditional Waiver of Waste Discharge Requirements. **Recommendation 3:** The dairy operators must take care to ensure that manure and sediment does not discharge to the ditch where it could flow to the Eel River.

Long term recommendation for the slough located west of Nissen Road: The slough should be studied to find out the reason that it does not flow to the Eel River and if possible, discontinue flow through the 1,350-foot culvert and route slough flow from the east of Nissen Road to the west of Nissen Road and on to discharge to the Eel River. Agencies will be contacted separately from this inspection report to study this possibility.

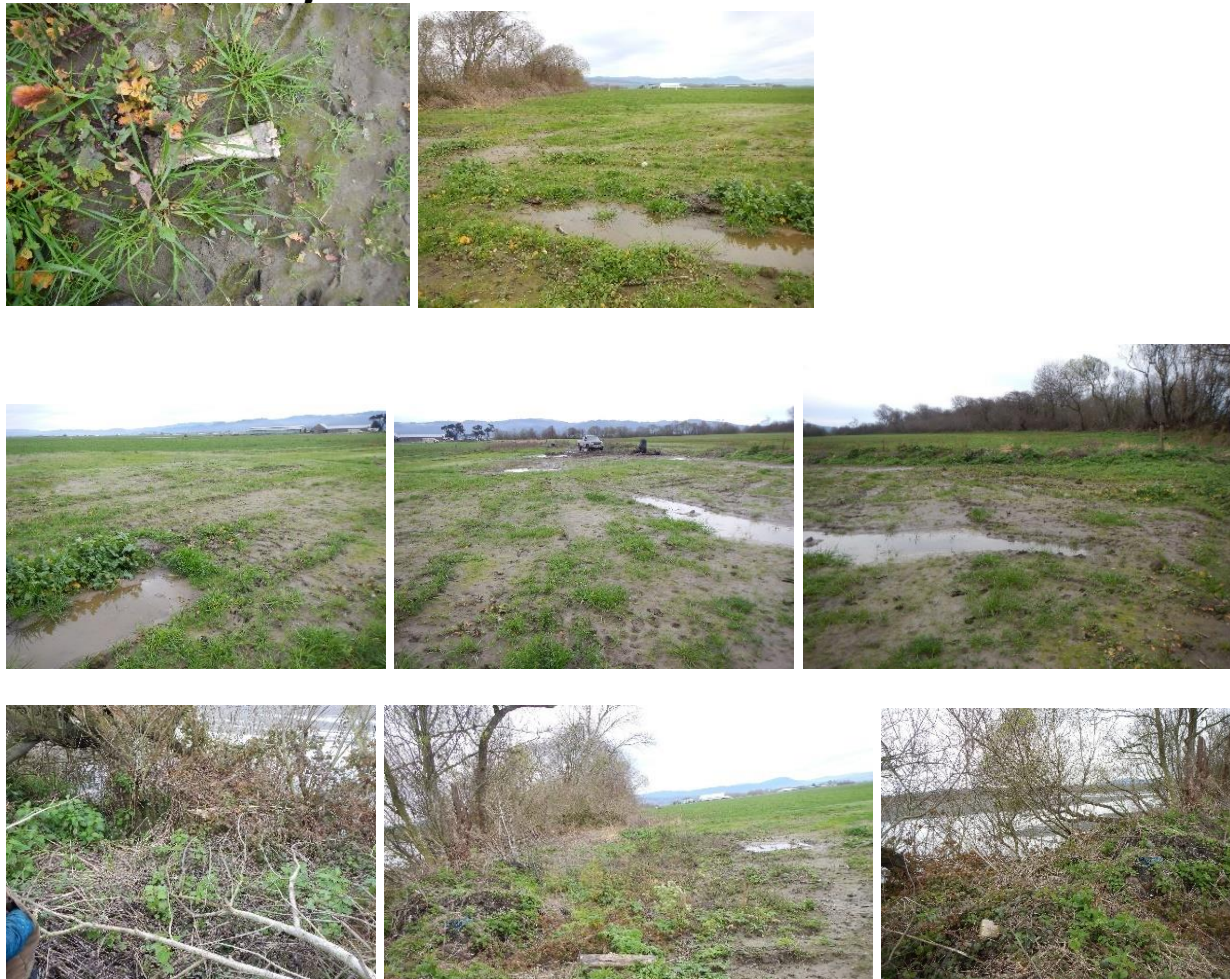
**Area C: Pasture Adjacent to Eel River**

The complaint about the northernmost pasture along the Eel River included water quality concern about the piles of dirt, wood, and dairy debris including dead cows and plastic wrap. Aerial photos of this area as given to Josh Levine, California Coastal Commission, in October 2018, showed the piles with the above listed contents. During the January 28, 2019, Inspection, Regional Water Board staff observed a smooth lot, no piles in the pasture, some bare dirt and some new plant growth, and one burned tree stump. On the north edge of the pasture were a few piles of soil with plants such as blackberry bushes growing on them. Victor pointed to the location of the outlet of the 32-inch diameter, 1,350-foot long culvert. The outlet of the culvert was not visible through the thick brush on the bank of the Eel River but flowing water, presumably from the subject culvert, could be heard.

The Conditional Waiver required a Water Quality Plan map. The map on file for Avelar Dairy shows green pasture at this northern location, however, the inspection revealed approximately 50 percent bare soil in this pasture. **Recommendation 4:** The soil in this pasture must be protected from disturbance to prevent sediment discharges to the Eel River and should not be used as a dumping ground for wood, manure, soil, or dairy debris piles. Also, in the future soil and debris are not to be pushed up against the bank of the Eel River. This area should be fully vegetated by the beginning of the winter rainy season

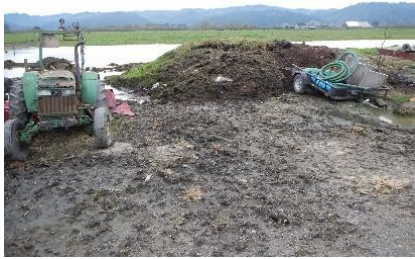
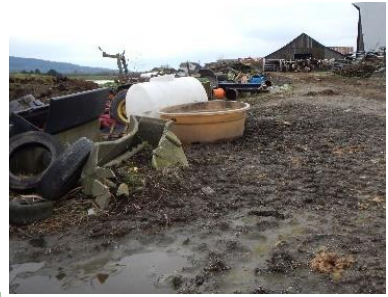
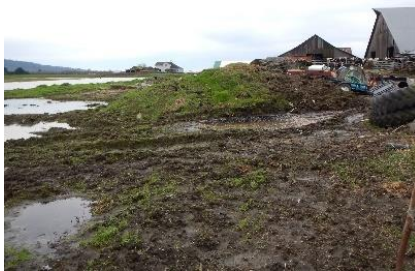
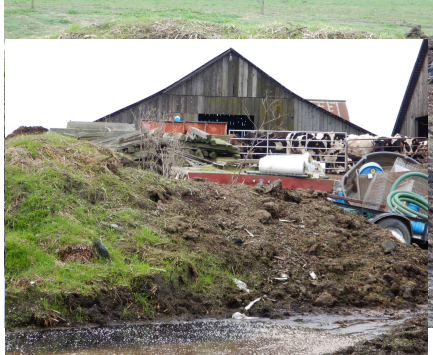
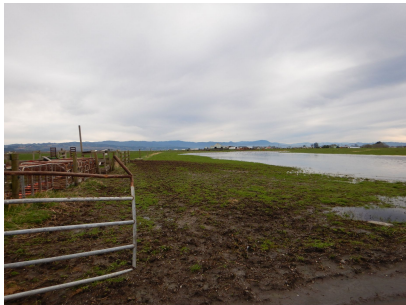
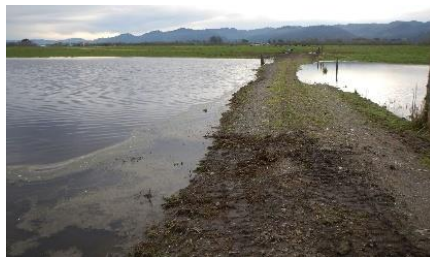
**Area D: Dairy Property At 3210 Goble Lane, Ferndale**

The Avelar property at 3210 Goble Lane was inspected due to the anonymous complaint that manure and blue plastic barrels were stacked along a tributary slough in the Salt River watershed. During the inspection, Regional Water Board staff observed dozens of cows housed at the barn and in the corral. The area is surrounded by dairy pasture. Dirt/manure piles with dead cow carcasses, several empty 55-gallon drums, tires, and other dairy debris were observed within or directly adjacent to the slough in the Salt River watershed. **Recommendation 5:** All manure, dirt, and dairy debris must be moved away from the slough and stabilized where it cannot discharge to waterways.

The current Water Quality Plan does not show the dairy buildings and corrals at 3210 Goble Lane as part of Avelar Dairy. **Recommendation 6:** The full parcels for the dairy barns, corrals, and storage area must be included in the maps for coverage under the dairy permit. Please certify to the Regional Water Board that this area is used for Avelar Dairy by amending the Notice of Intent, signed letter to the Regional Water Board, or by adding it to the next certified report submitted such as the Annual Report (see question regarding changes on page 1).
